Reg. No. SKA2013012

FINAL REPORT

on investigation of accident of
sports flying device / SFD
Registration No. **OM-H043**

Date: 16.08.2013

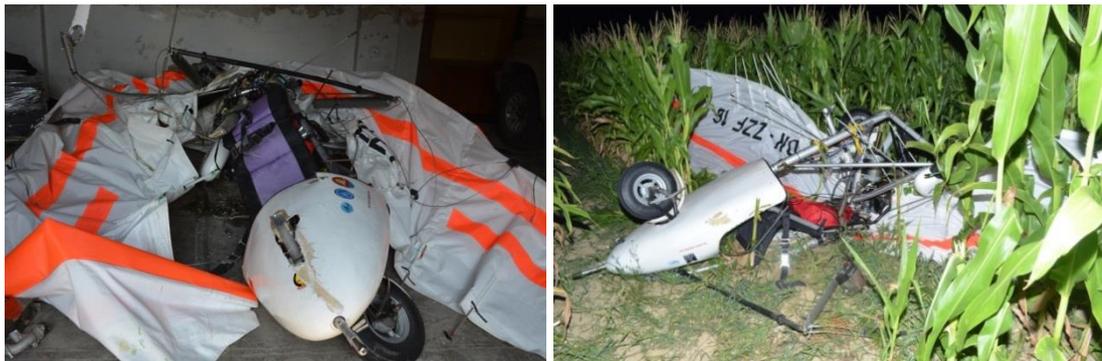
PHG was destroyed in the air accident – completely destroyed landing gear, broken wing leading edge, damaged canvas and bent struts and pipes of the landing gear.

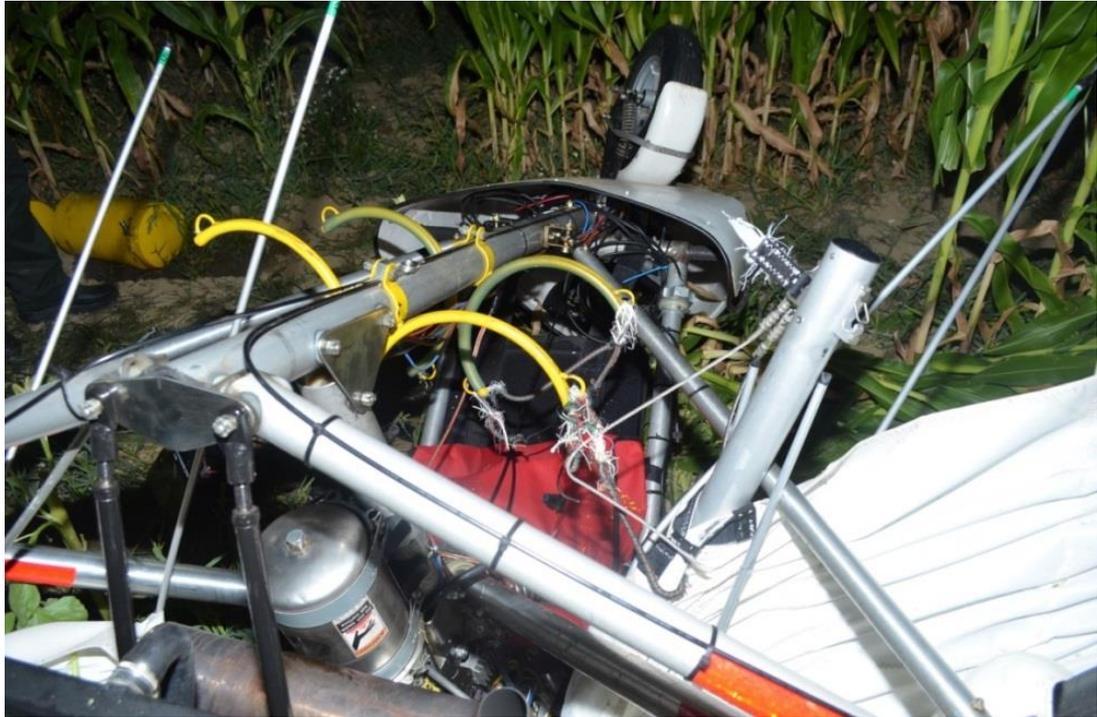
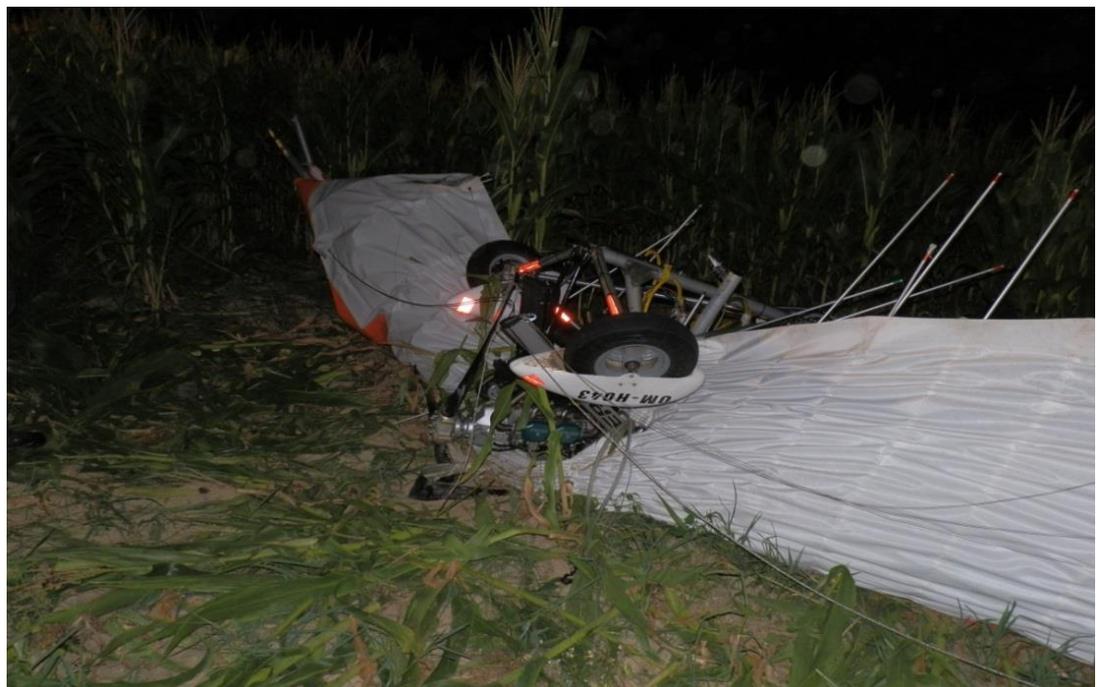
PHG fell to the corn field without significant obstacles.

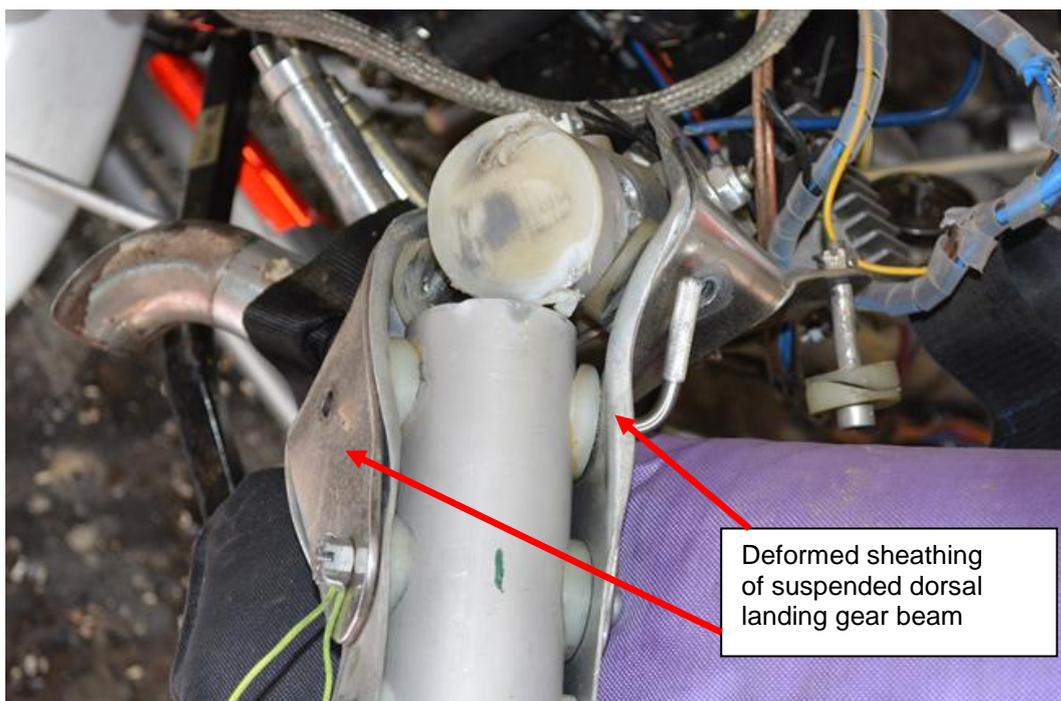
The picture clearly shows deformation of sheathing of suspended dorsal landing gear beam which probably lacked the required strength for this type of configuration.

- the wing stall was caused by misalignment of the landing gear and the wing, which resulted in uneven wing flow-around from the left and right side,
- insufficient strength of suspended dorsal landing gear beam sheathing for given configuration,
- large front hood without use of stabilizing aerodynamic elements behind the centre of gravity,
- The position of the centre of gravity of the landing gear was changed due to the replacement of the original engine for a heavier and more efficient engine.

- to conduct the following modifications on all PHGs through authorized technicians with their entry into SFD recorders:
 - to place the engine actuators (gas lever) control on the control trapeze or front landing gear pedal,
 - to check the suspension of the landing gear – its position,
 - split dorsal beam – to use material with higher torsion strength for the joint.

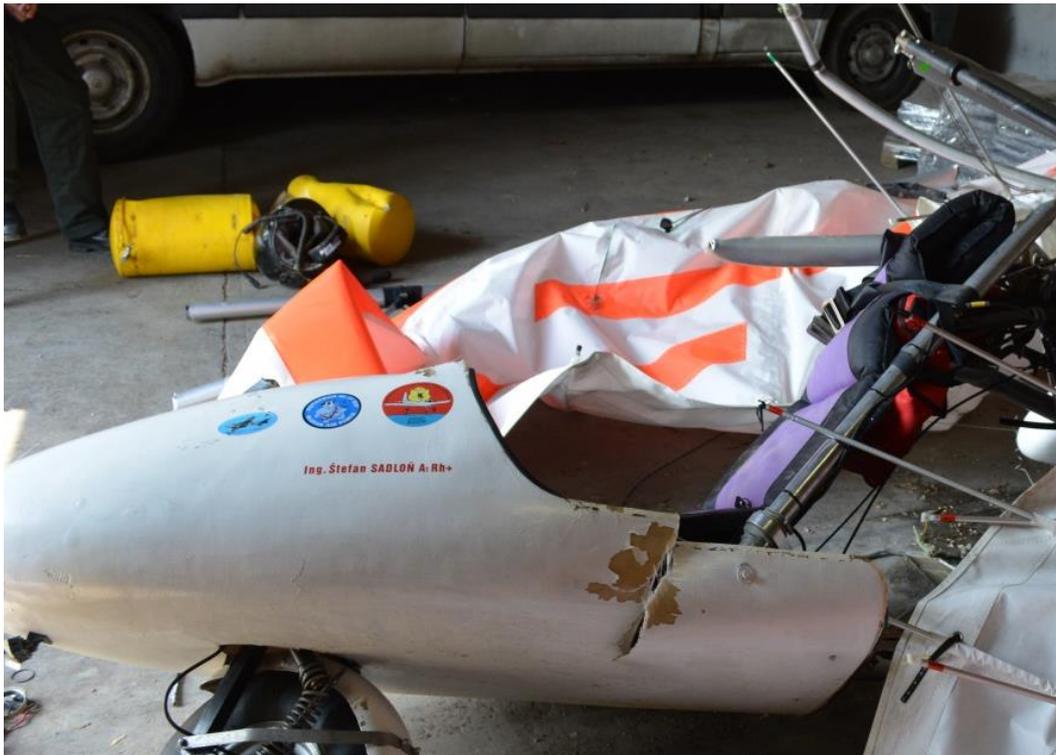
The large front hood without use of stabilizing aerodynamic elements behind the center of gravity.

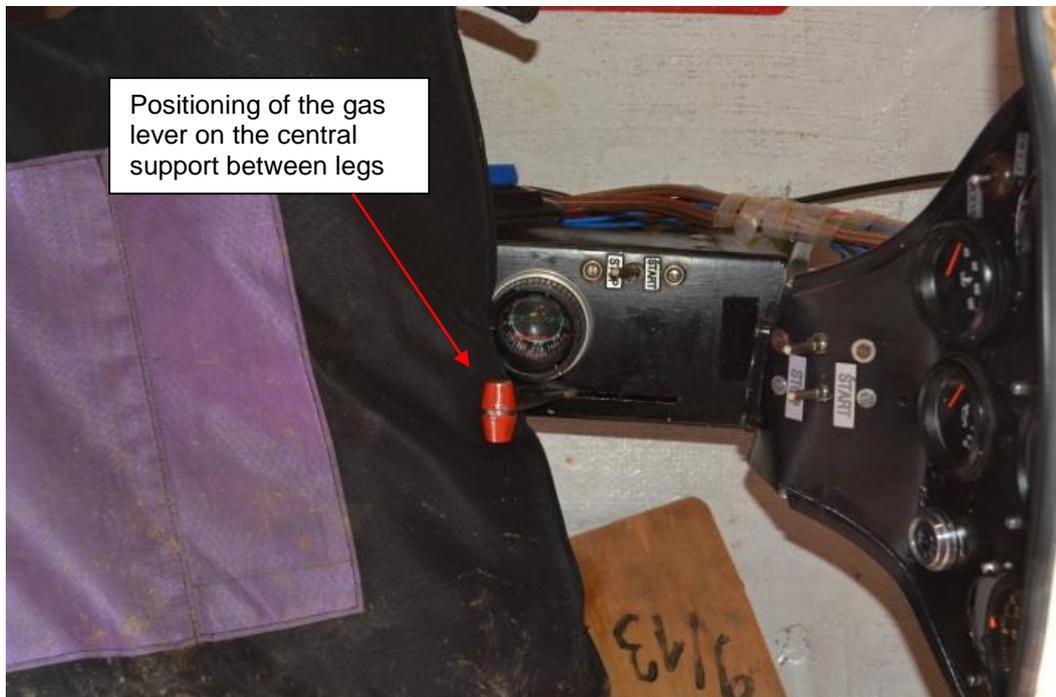
The positioning of gas lever was unsuitable for engine control in crisis situations, because in case of change of the engine mode the pilot had to move his hand from the control trapeze to the area of the central landing gear support.

- the position of the gas lever did not allow the control of engine power in crisis situations,
- the position of the PHG control trapeze did not allow the reduction of the air incidence angle after the take-off.
